NRW ASSESSMENT AND REDUCTION PILOT STUDY

Kelvin Romain

CEO WASA

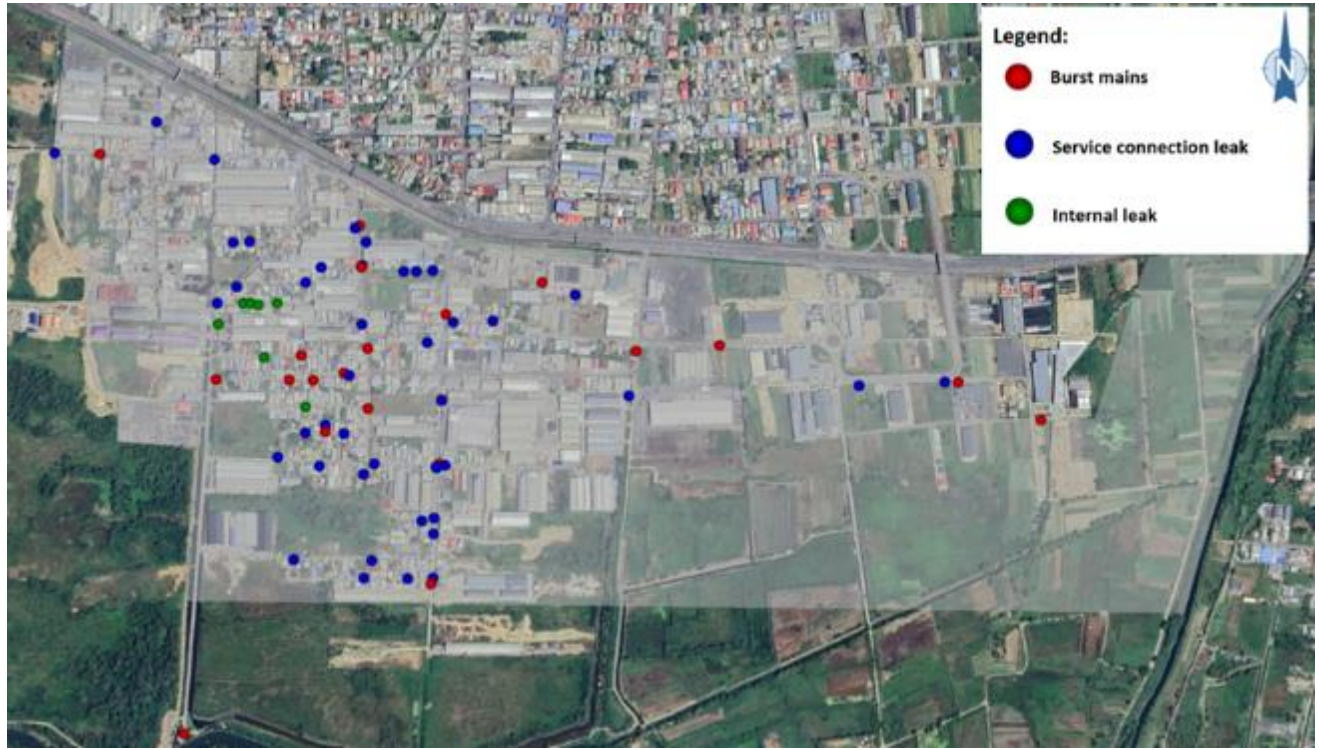
Leak location clustering

Type of Leak	Days
Age of oldest unrepaired leak	95
Average age of unrepaired leaks	51
Average turn around-time of leak repair	32
Average time before a leak is endorsed to repair team	2

Leak Type	Repaired Leaks	Backlog
Burst Main	21	2
Service Connection	38	9
Internal Leak	1	6
GRAND TOTAL	60	17

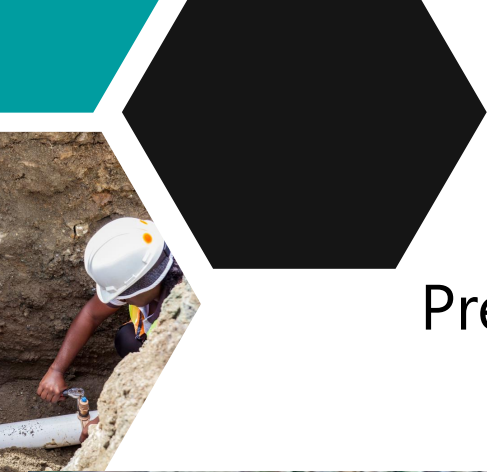
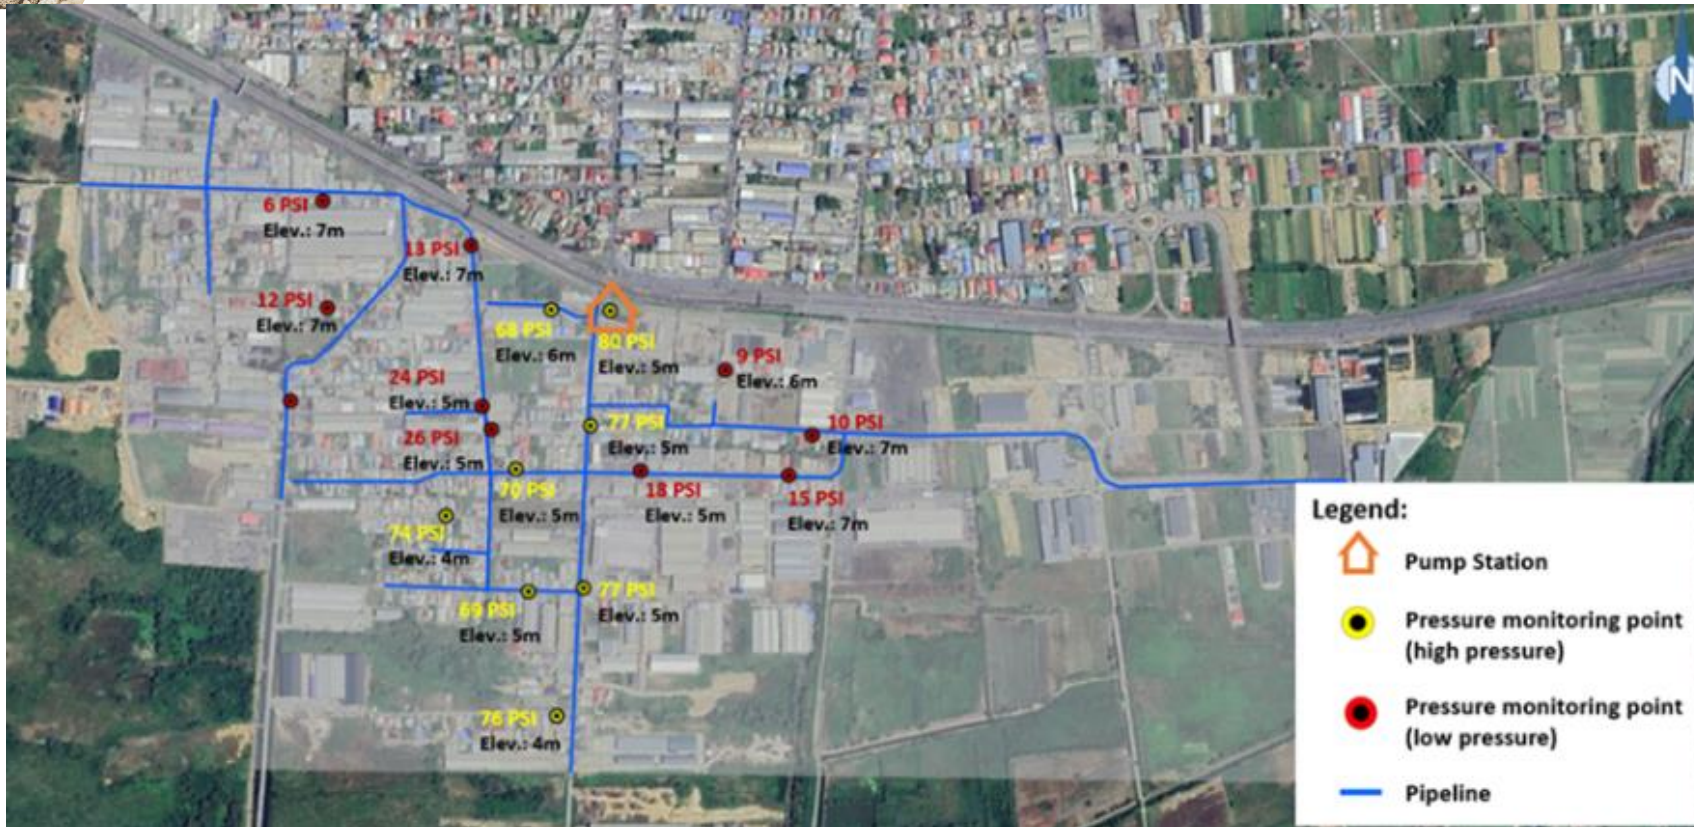
El Socorro South – Spot Pressure Survey

Pressure investigation prior to installing a PRV at the inlet to understand the distribution of the water pressure across the network

- investigate possible cause(s) of the reduction of pressure between the western and eastern side of the DMA
- Installation of loggers at intersection of Streets Chanka Trace and Chotoo Road and the roundabout in El Socorro Ext. 2

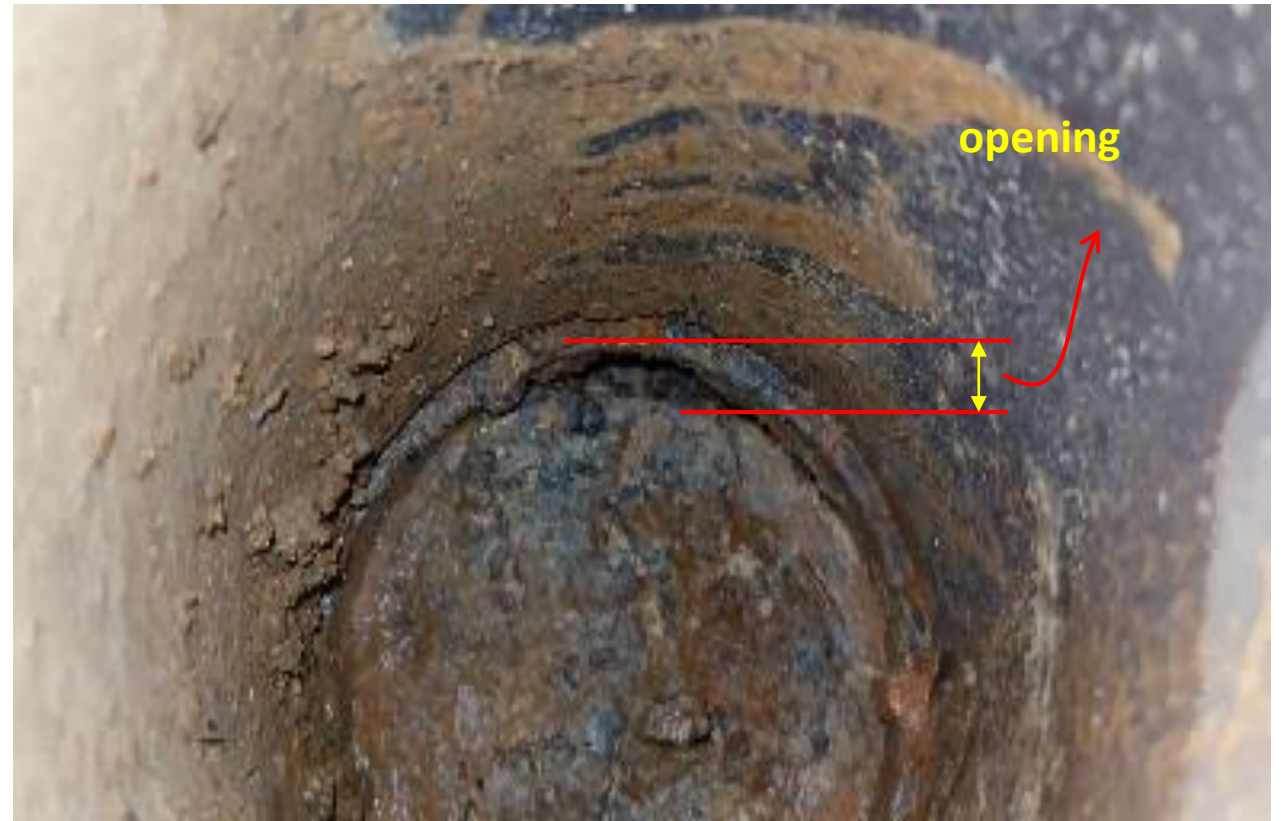
Replaced 4" valve at El Socorro roundabout

- Checked logged data to confirm pressure differences
- Top sounding to locate the gate valves
 - pinpointed 2 locations endorsed to WASA for replacement
- 1 of the 2 valves was excavated, status: almost closed causing the considerable pressure to drop across the network.

The valve was replaced and set at fully open and the effect on pressure is being monitored

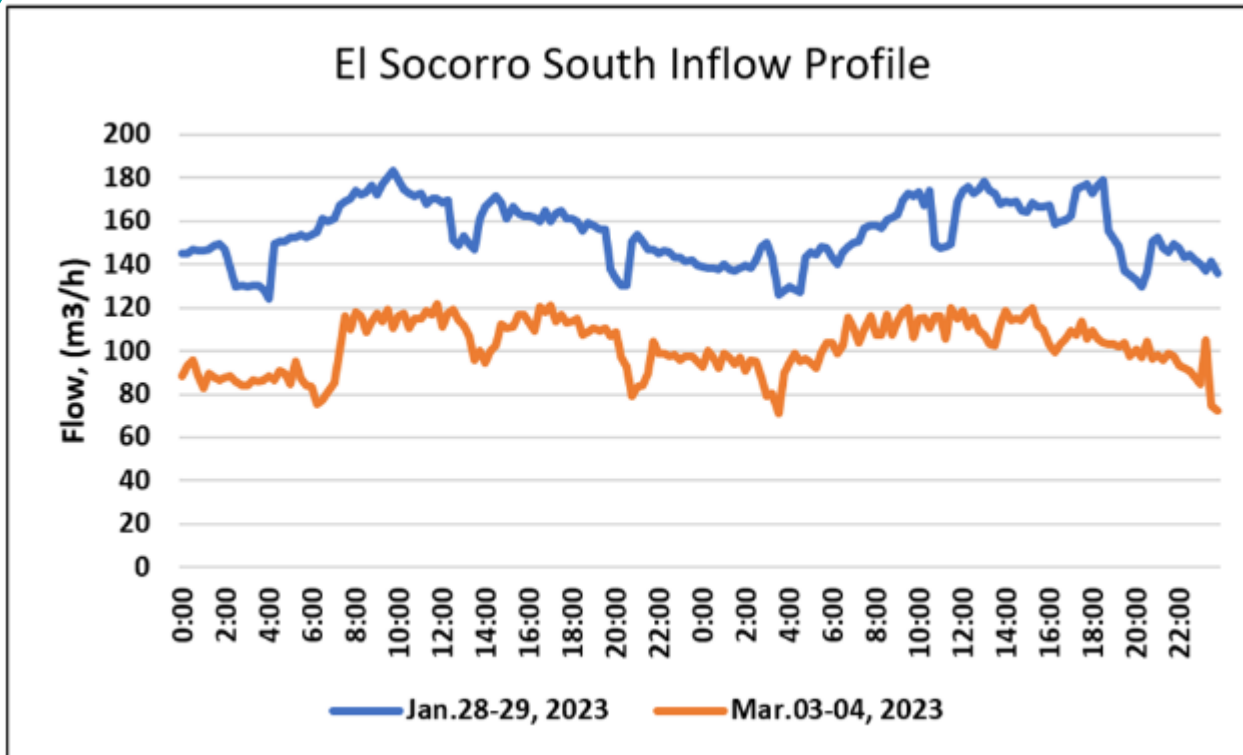
El Socorro South – Observations

- Repaired 35 leaks
- Average flow rate Jan. 28-29 was 154.40 m³/h
- Average flow rate Mar. 03-04 was 102.23 m³/h
- Saving: 52.18 m³/h or equivalent to 11,480 IG/h
- Savings achieved at 61 psi

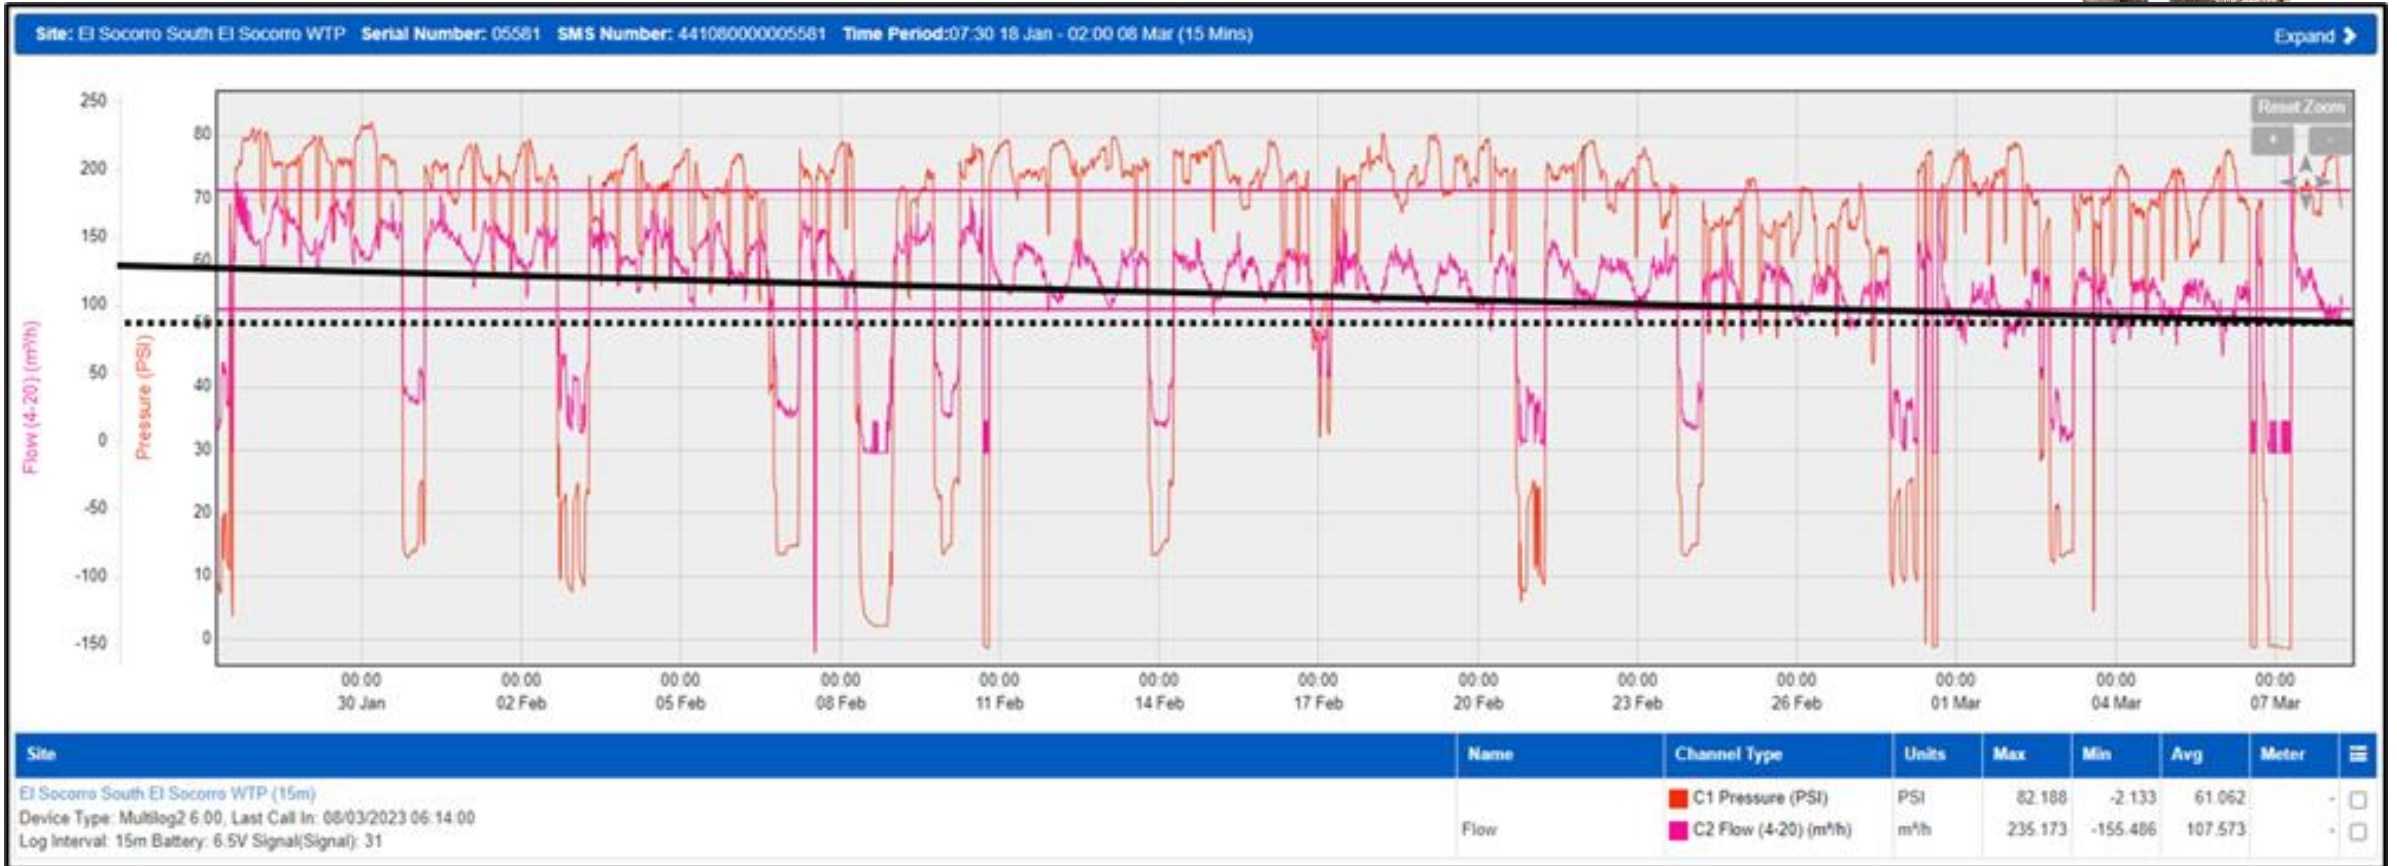
El Socorro South – Observations

Average pressure is **61psi** – pressure reduction will further reduce losses, new leaks and extend life of assets
Pressure could possibly be reduced to **30psi** which means leakage will be halved, new leak will be reduced by about **50%**
