Portmore NRW Reduction Co-Management Program

Leak Detection technologies and strategies in Portmore
23rd March 2023

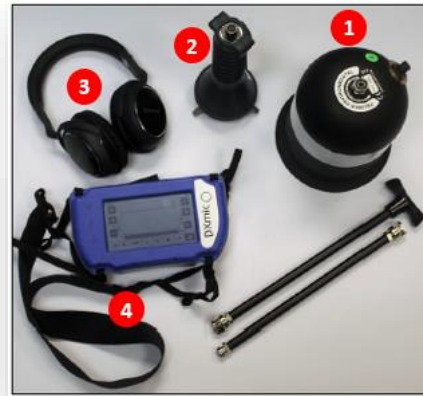
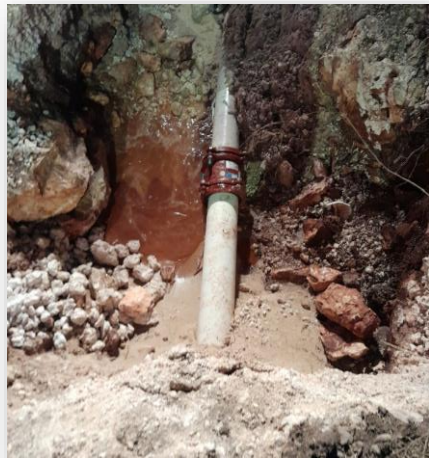
CONVENTIONAL ACOUSTIC TECHNOLOGY EQUIPMENT

- Water leak creates an **energy disturbance (vibration)**
- Vibration passes through the water and the pipe wall in form of an **acoustic wave**
- Acoustic wave **travels in all directions, becoming weaker with distance from leak**
- This acoustic wave can be detected using a conventional **acoustic equipment (DXMic in Jamaica)**
- Conventional acoustic equipment used includes:
 - ➊ Acoustic shielded **ground microphone** used on hard ground surfaces
 - ➋ **Tripod foot** used on uneven surfaces
 - ➌ High quality **headphones**
 - ➍ **DXMic device** used to display all the characteristics of a sound and to apply filters, increase the sound volume and microphone sensitivity

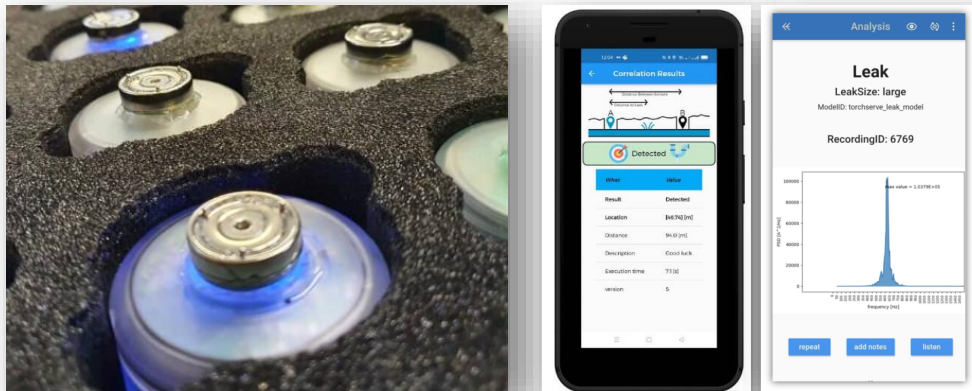
ARTIFICIAL INTELLIGENCE - FIDO SOLUTION

Formula

$$L = \frac{D - v \times T}{2}$$

Sample data

Time difference: $T = 0,021\text{ms}$
Velocity: $v = 1280\text{ m/s}$
Length: $D = 93,5\text{ m}$

Result

$L = (93,5\text{ m} - 1280\text{ m/s} \cdot 0,021\text{ s})/2$
 $= 33,3\text{ m}$

- **Cloud Correlation technology**
- **Use of FIDO Bugs** – small microphones attached to access points of the network (3 years battery life)
- **AI technology** to locate and validate leak noises (92% accuracy)
- **Analyze all the noises**, including background noises and compare them to more than **2.4 million noise samples** stored in their library (the largest in the world)
- **Calculate the size of the leaks** relative to a baseline (90% accuracy)
- **Integration with GIS** and other softwares
- **Data-as-a-service (DAAS)**
- **No hardware investment** – Only pays to have access to data
- Works in **every pipe material and diameter**
- Works in **any pressure condition**
- **24/7 data recording** (avoiding night works)
- **No need of human analysis**, eliminating the human error

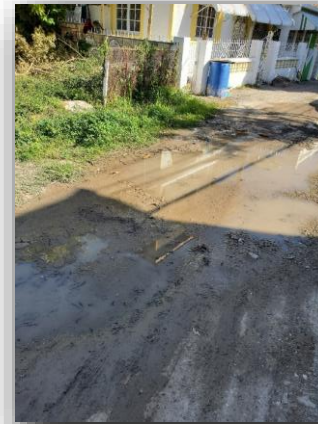
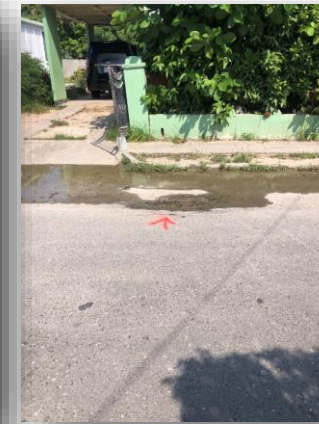
VISUAL INSPECTION

- **Quick survey** to find all the visible leaks
- **Big component** of real leaks
- **High cost-benefit** activity
- A system with low number of visible leaks is **good for public perception and utility reputation**
