NRW ASSESSMENT AND REDUCTION PILOT STUDY

Kelvin Romain

CEO WASA

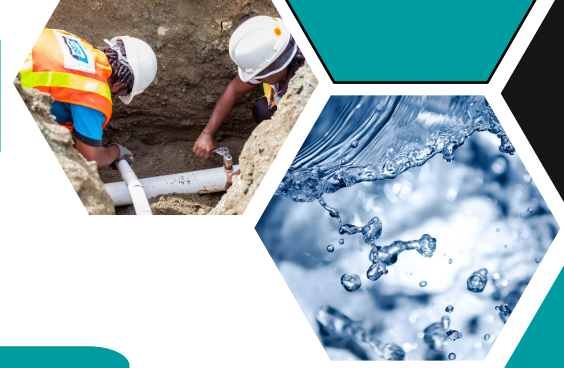
El Socorro South – Pressure Monitoring Points

- Checked logged data to confirm pressure differences
- Top sounding to locate the gate valves
 - pinpointed 2 locations endorsed to WASA for replacement
- 1 of the 2 valves was excavated, status: almost closed causing the considerable pressure to drop across the network.

The valve was replaced and set at fully open and the effect on pressure is being monitored

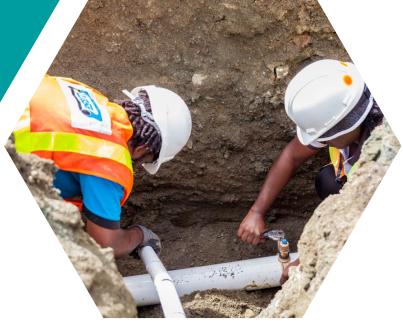
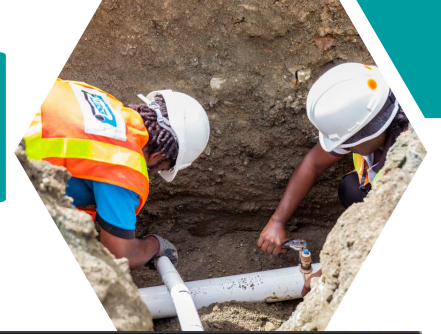
El Socorro South – Observations

Average pressure is **61psi** – pressure reduction will further reduce losses, new leaks and extend life of assets
Pressure could possibly be reduced to **30psi** which means leakage will be halved, new leak will be reduced by about **50%**
